Test Report

Report no. 21101265

Ring gap analysis on a pipe section for the gap between the old pipe and the CIPP liner

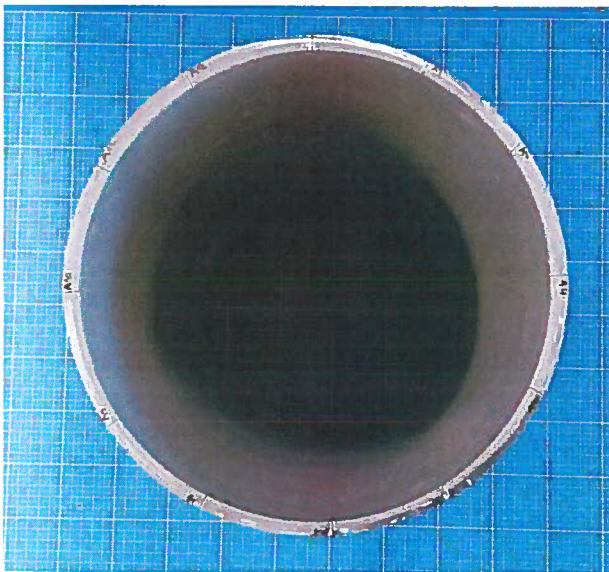
Fig. 1: Material sample 21101265 with 12 marks in 30° intervals (side A)

On the INPIPE liner in a steel shell pipe that was provided as sample material we could not determine any ring gap nor gap formation. The hose liner is in full contact with the shell pipe.

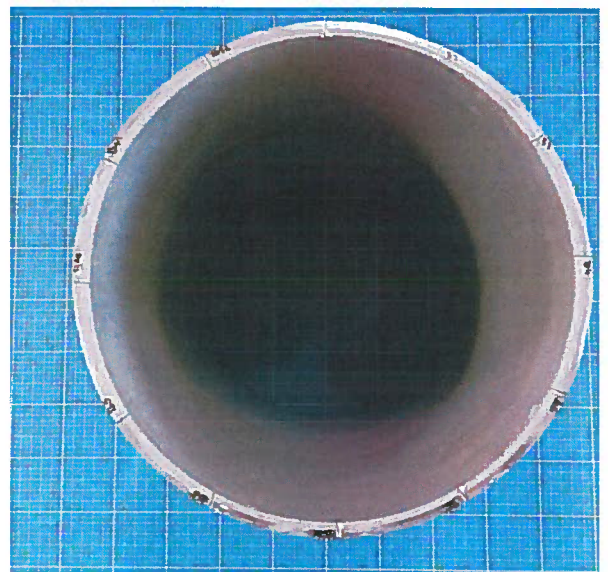
Fig. 2: Material sample 21101265 with 12 marks in 30° intervals (side B)
