Railway culverts are quicker and safer to repair using the Inpipe method

Disintegrating culverts that cause track subsidence has always been a headache for the National Swedish Rail Administration (Banverket). But repairs can now be carried out quicker and easier without disrupting rail services. Skelleftehamn-based Railcare lining is using the Inpipe method to repair hundred-year-old railway culverts.

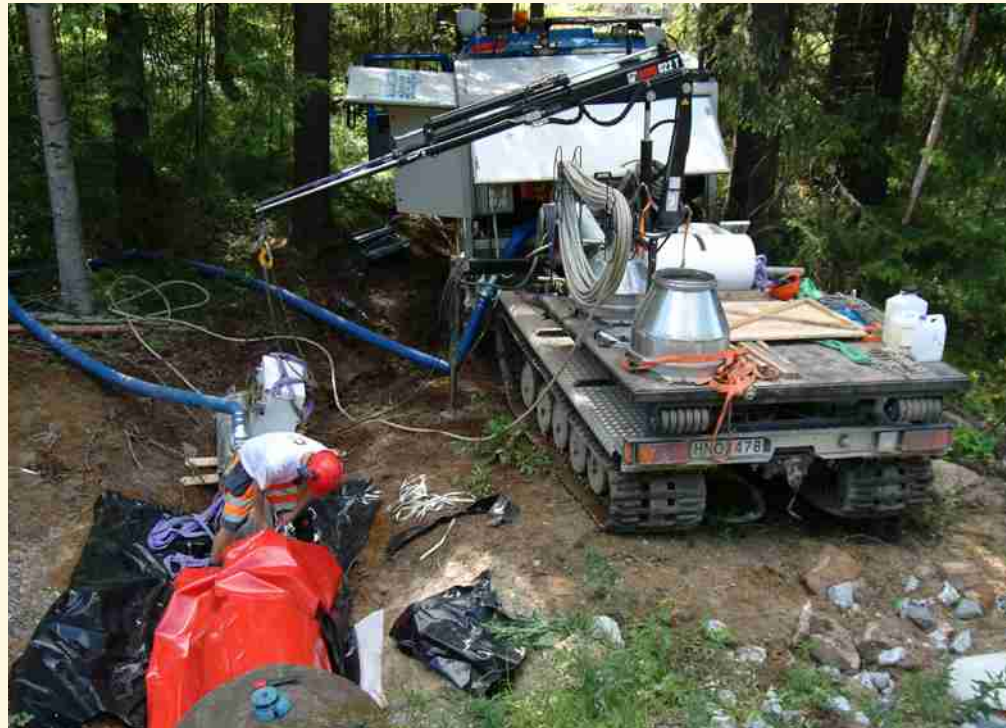
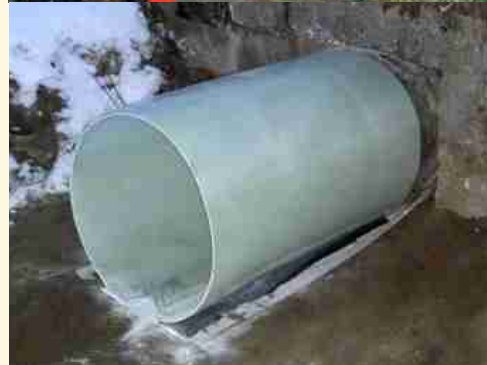
Equipment mounted on a tracked vehicle enables the work to be carried out offroad.

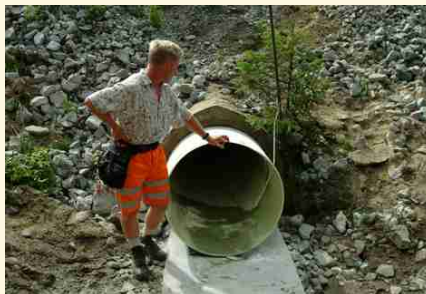
Because the plastic expands out at the opening, the new liner also functions as an anchor point for the culvert.

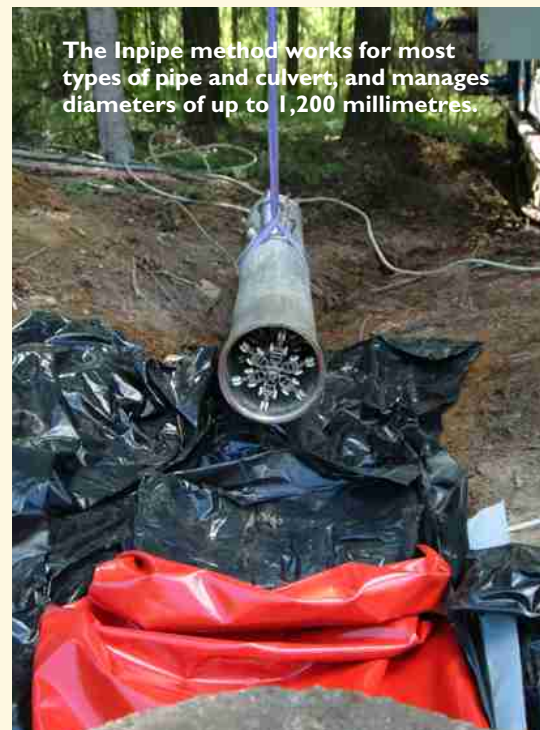
The Inpipe method works for most types of pipe and culvert, and manages diameters of up to 1,200 millimetres.
