# Railway culverts are quicker and safer to repair using the Inpipe method

*Disintegrating culverts that cause track subsidence has always been a headache for the National Swedish Rail Administration (Banverket). But repairs can now be carried out quicker and easier without disrupting rail services. Skelleftehamn-based Railcare lining is using the Inpipe method to repair hundred-year-old railway culverts.*

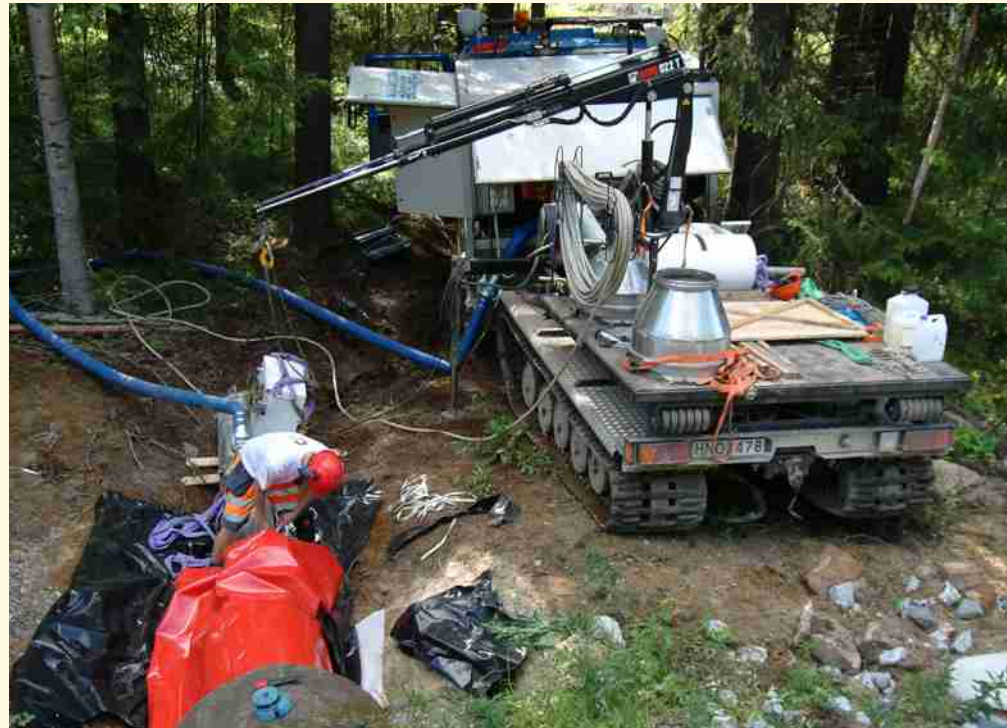
**Equipment mounted on a tracked vehicle enables the work to be carried out offroad.**

For Railcare lining, who are carrying out the work, the vehicle makes it easier to navigate through rough terrain and improves accessibility during winter.

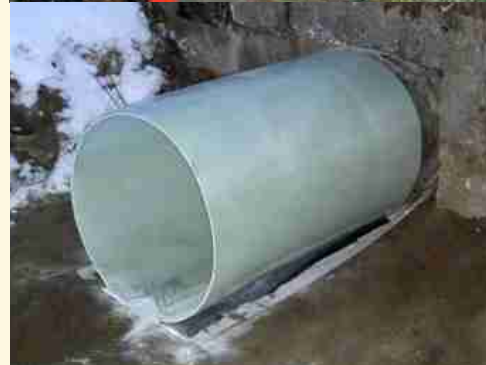
**The fibreglass lining adapts perfectly to the shape of the culvert and when UV cured holds the stones firmly in place. The existing culvert can also be extended to the required length by letting the liner continue outside the opening.**

“At increased load, the granite stones glide apart and the sleeper chippings penetrate the culverts, causing depressions in the track bedding that could lead to derailment. The Inpipe method creates a tight-fitting culvert and holds the granite stones in place. When tracks were lifted to level out depressions, the culverts were also extended with concrete pipe at both ends, but the concrete did not set easily in the old stone culverts. That’s not a problem anymore because we now have one length of solid pipe that can’t be pulled apart.”

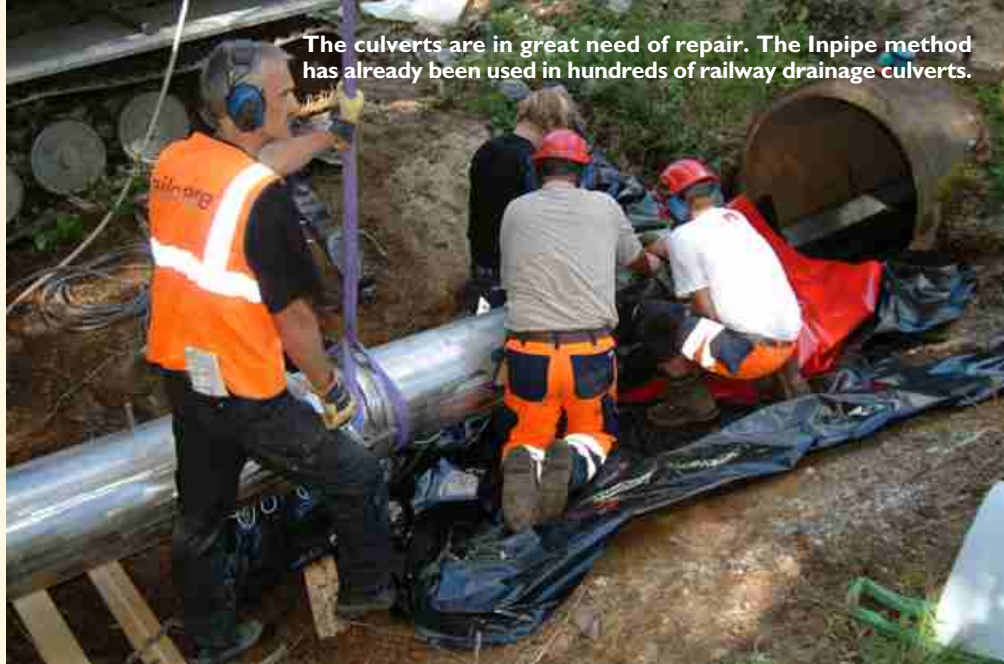
The culverts are in great need of repair. The Inpipe method has already been used in hundreds of railway drainage culverts.

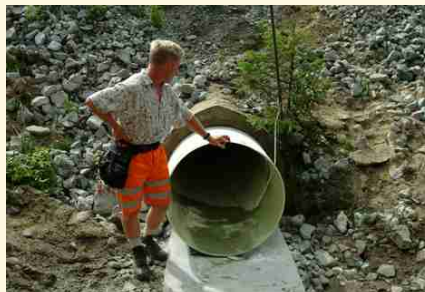
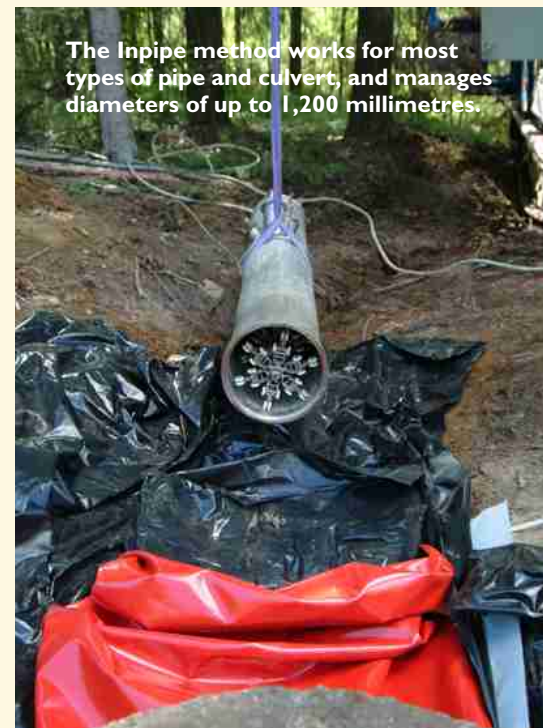
**Because the plastic expands out at the opening, the new liner also functions as an anchor point for the culvert.**

The Inpipe method works for most types of pipe and culvert, and manages diameters of up to 1,200 millimetres.
